Salem Church Road Pedestrian Safety Study

Old Baltimore Pike to SR 4

October 2023

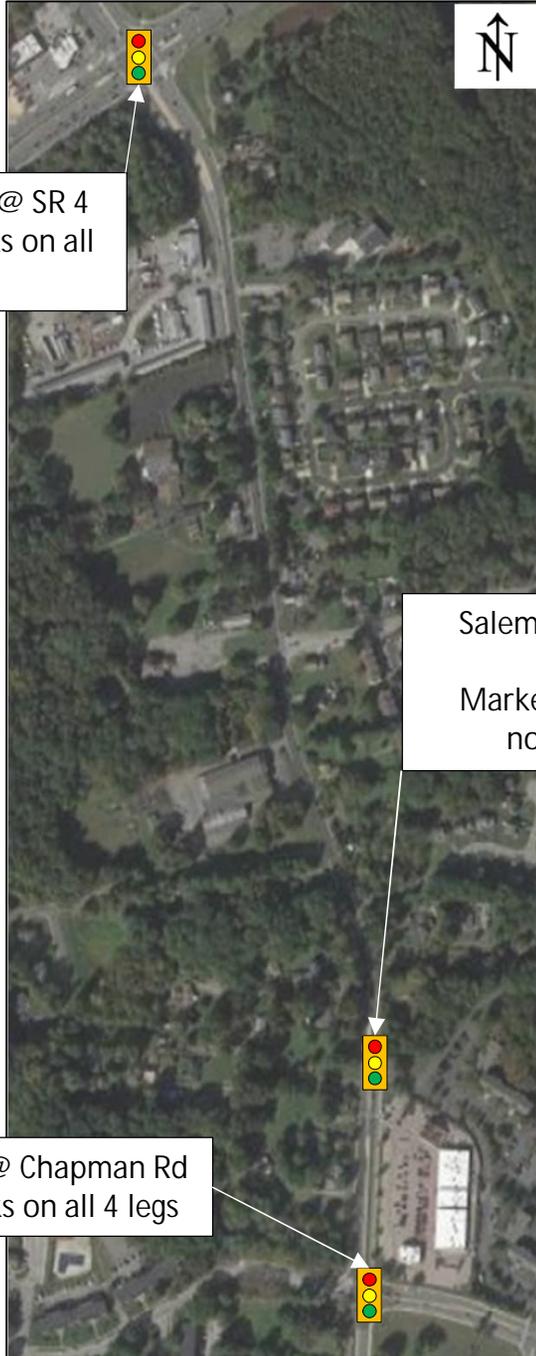
Salem Church Rd @ SR 4
Marked crosswalks on all
4 legs

Salem Church Rd @ Salem
Village Square
Marked crosswalks on the
north and east legs

Salem Church Rd @ Chapman Rd
Marked crosswalks on all 4 legs

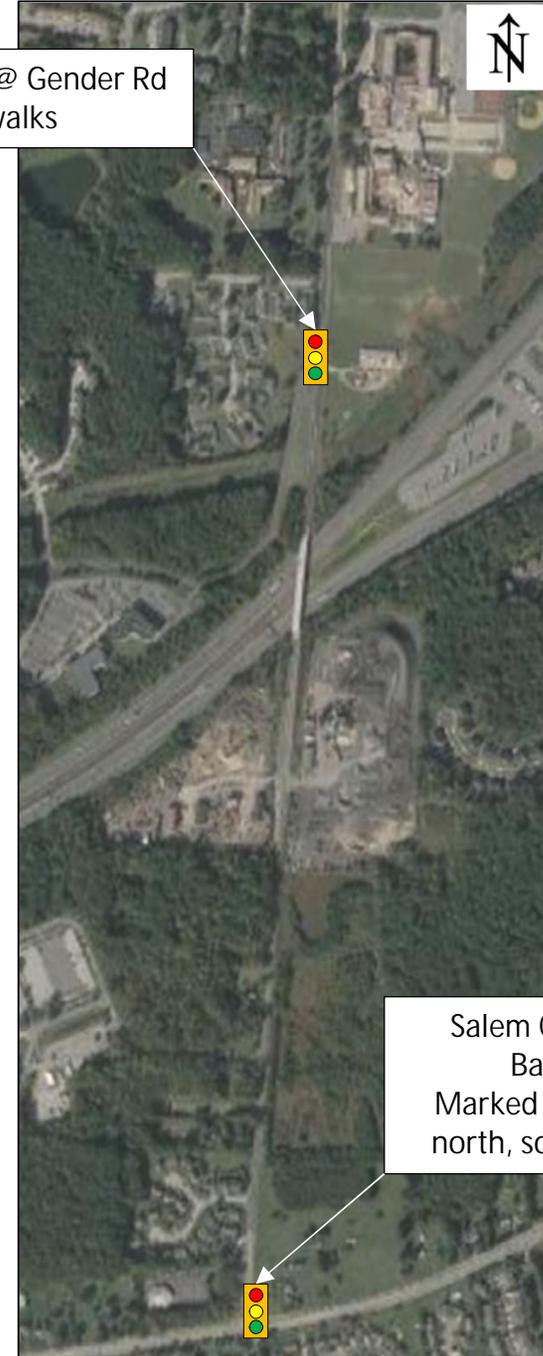
Salem Church Rd @ Gender Rd
No crosswalks

Salem Church Rd @ Old
Baltimore Pike
Marked crosswalks on the
north, south, and east legs

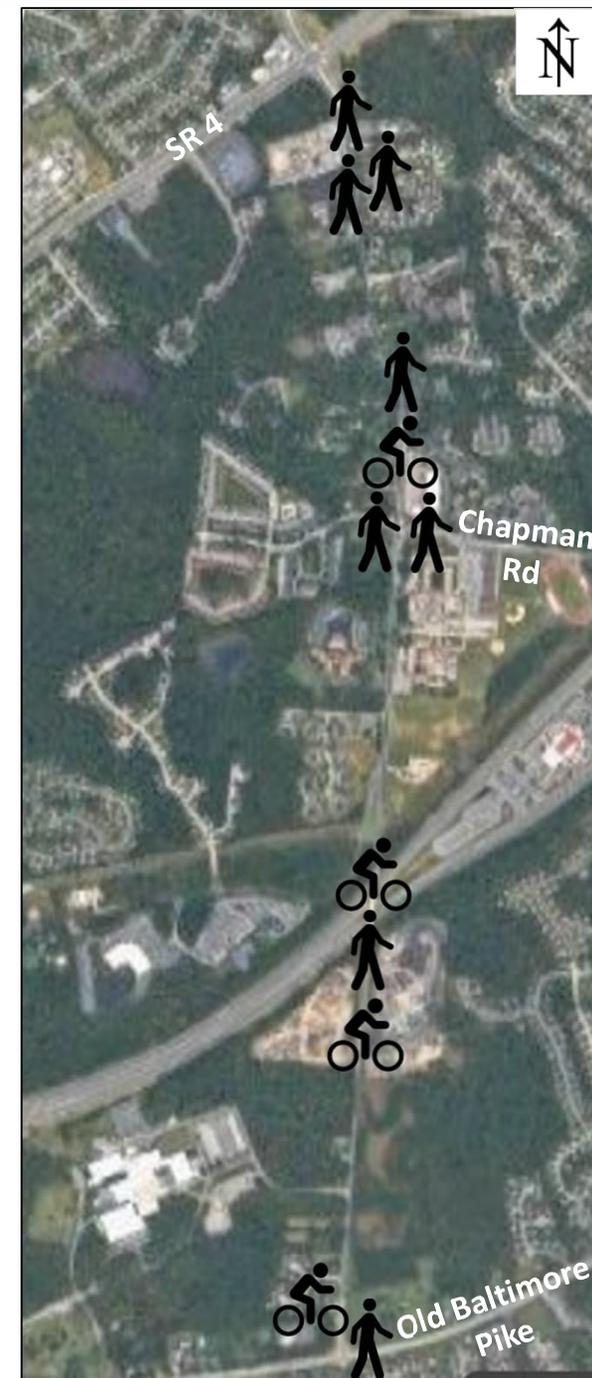
- On February 18, 2022 at 10:12 PM a 30-year-old bicyclist was killed while traveling in the SB lane between Adel Dr and Old Baltimore Pike. A SB vehicle attempted to veer left at the same time as the bicyclist, resulting in the collision.

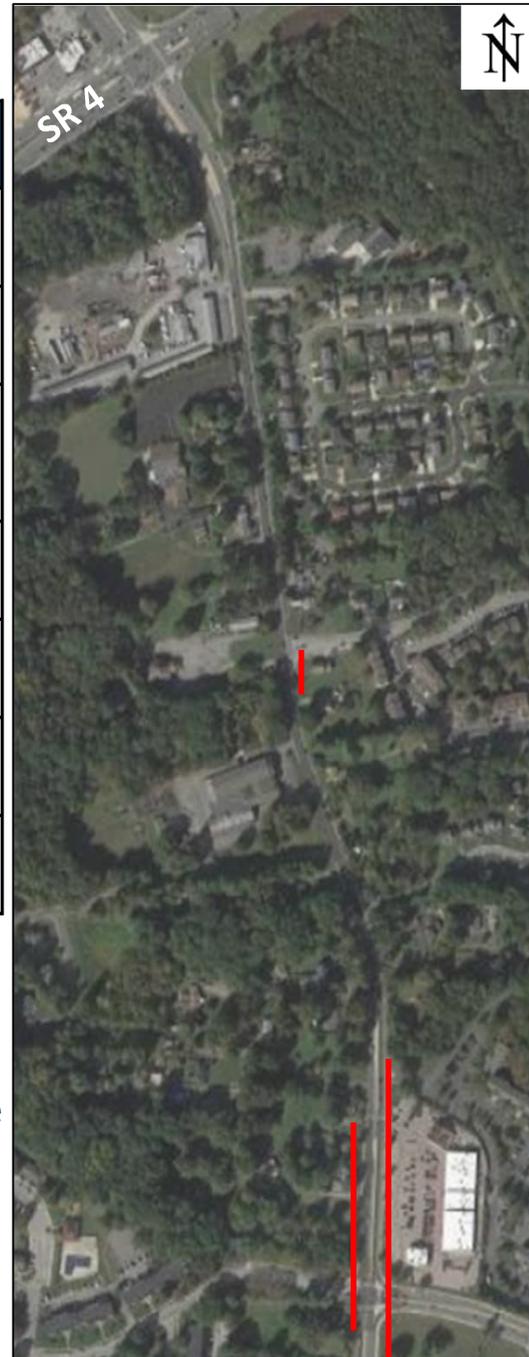
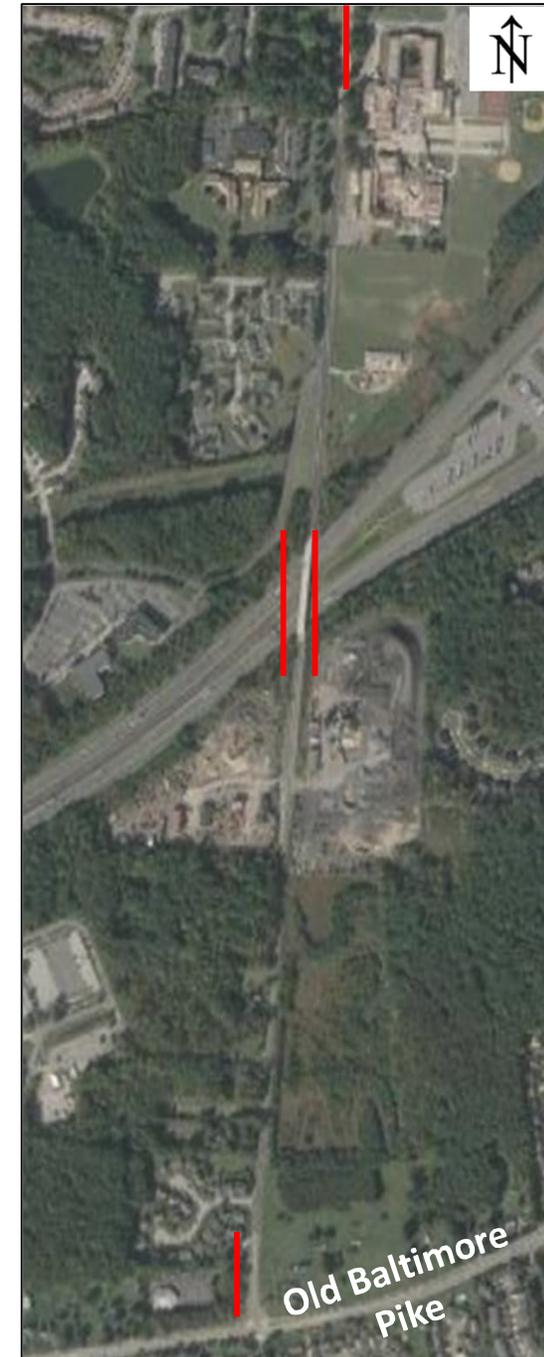
Sidewalk Gap Assessment

- Sidewalks are shown in red

Beginning Point	Ending Point	Distance
SB Salem Church Road	Salem Village Square Shopping Center	20 ft south of Oakdale Road	625 ft
	Northern edge of I-95 bridge	Southern edge of I-95 bridge	550 ft
	275 ft south of Mapleshade Road	Southern study area limits (Old Baltimore Pike)	320 ft
NB Salem Church Road	Southern edge of I-95 bridge	Northern edge of I-95 bridge	550 ft
	Northern Christiana High School driveway	Sandalwood Drive	1,240 ft
	50 ft south of Elm Drive	Elm Drive	50 ft
		Total sidewalk distance:	3,335 ft

2 miles of roadway = 21,120 ft of possible sidewalk

- Identify which sidewalk gaps, if any, should be prioritized
- Consider DeIDOT's ADA Transition Plan along the corridor to help improve multi-modal infrastructure

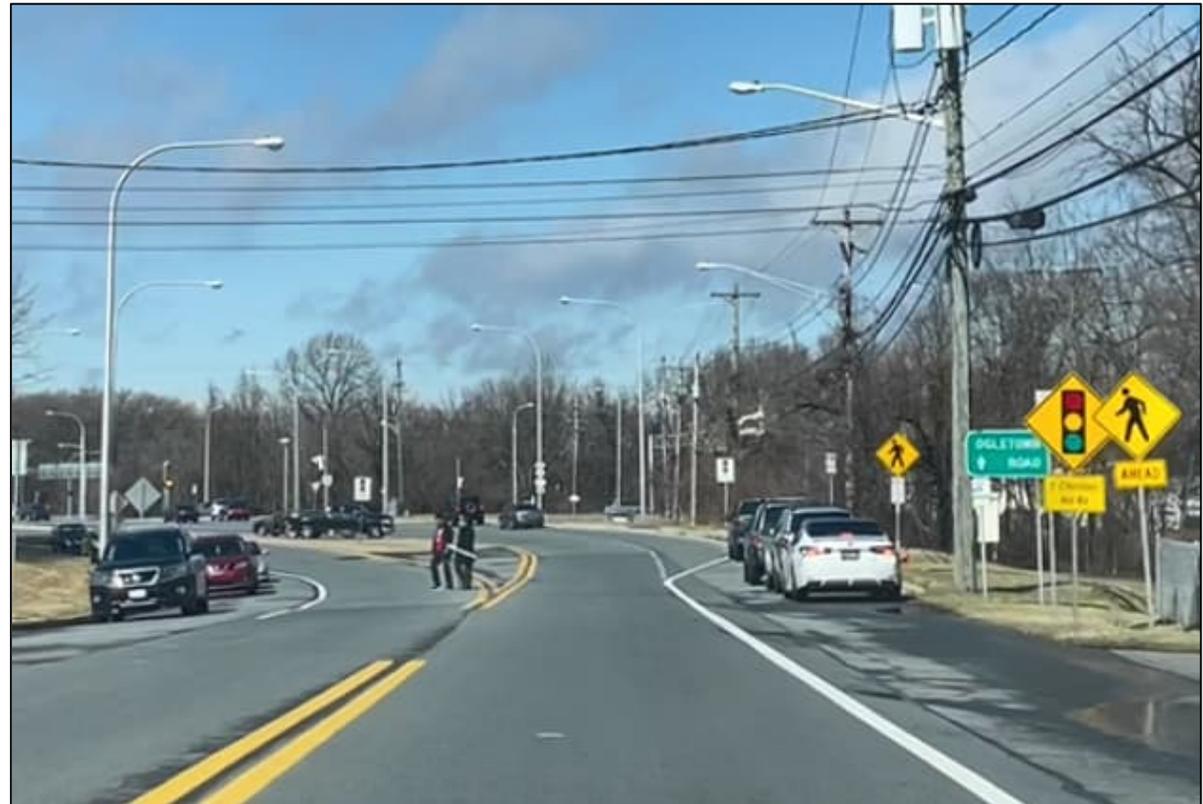
- Occurred on January 14, 2022, between 12:00 PM-1:00 PM to coincide with Islamic Society of Delaware's popular service
- Vehicles utilized the northbound and southbound shoulders to park during ISD service, along with the wide concrete median south of SR 4
- Observed 103 pedestrians cross Salem Church Road during one-hour period
 - No sidewalks or crosswalks are in the vicinity of ISD
- Pedestrians often had trouble finding a gap in traffic to cross the road

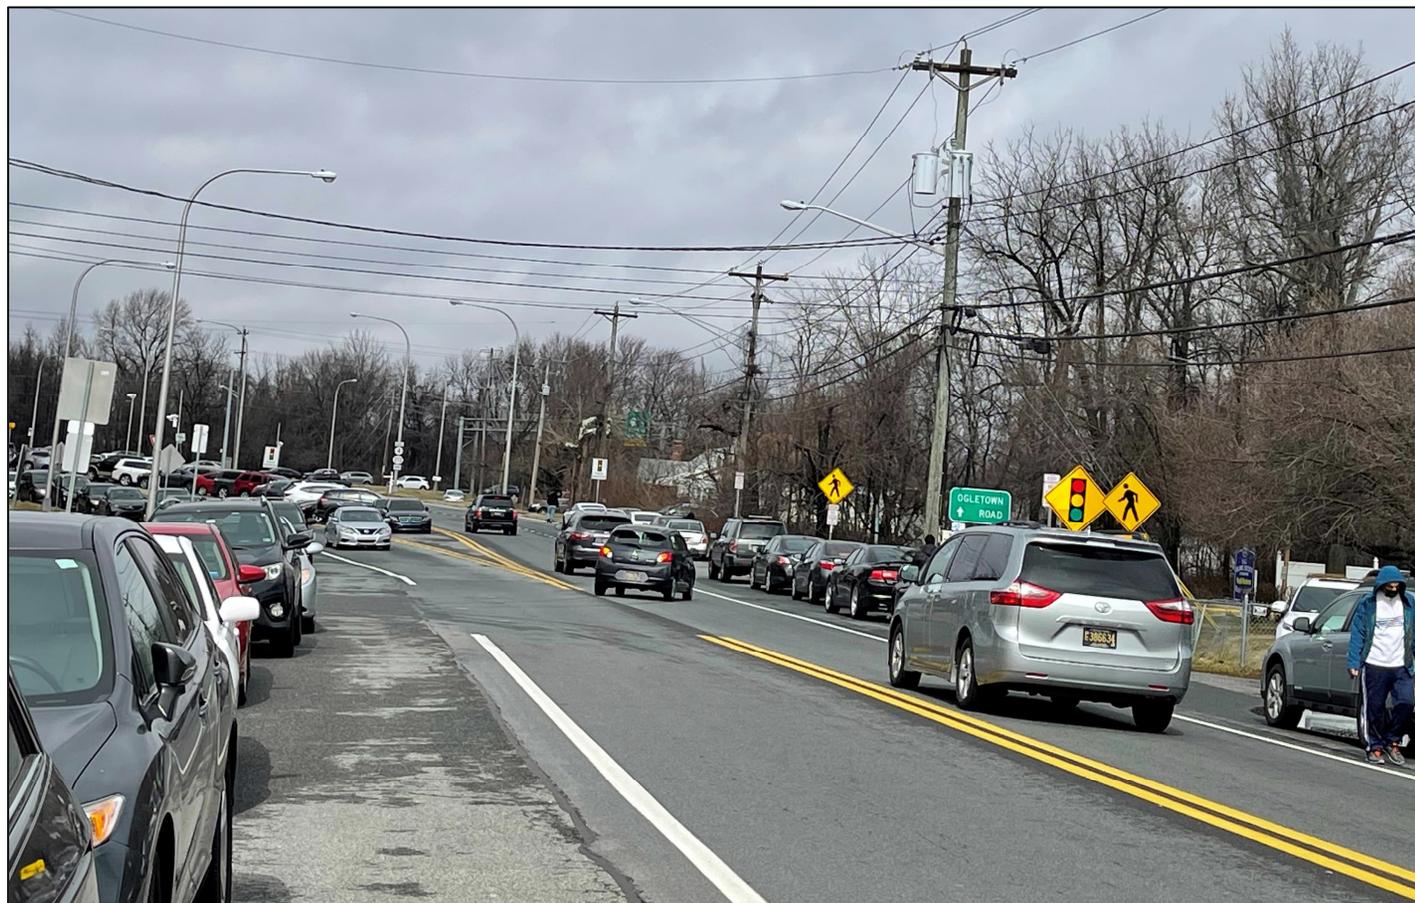
- A member of the ISD congregation wore a reflective vest and stopped traffic on Salem Church Road so that pedestrians could cross
 - This person also occasionally stopped traffic for vehicles exiting the business park across from ISD
- The Delaware Saengerbund & Library parking lot was completely full, while The Journey church parking lot contained 3 vehicles
- At approximately 12:50 PM, the “crossing guard” stopped NB traffic to let vehicles exit the ISD parking lot
- Most vehicles parked along the shoulders were cleared at approximately 1:00 PM (it should be noted that after Daylight Saving time on 4/13/22, the peak Friday period changed from 12:00-1:00 PM to 1:00-2:00 PM)

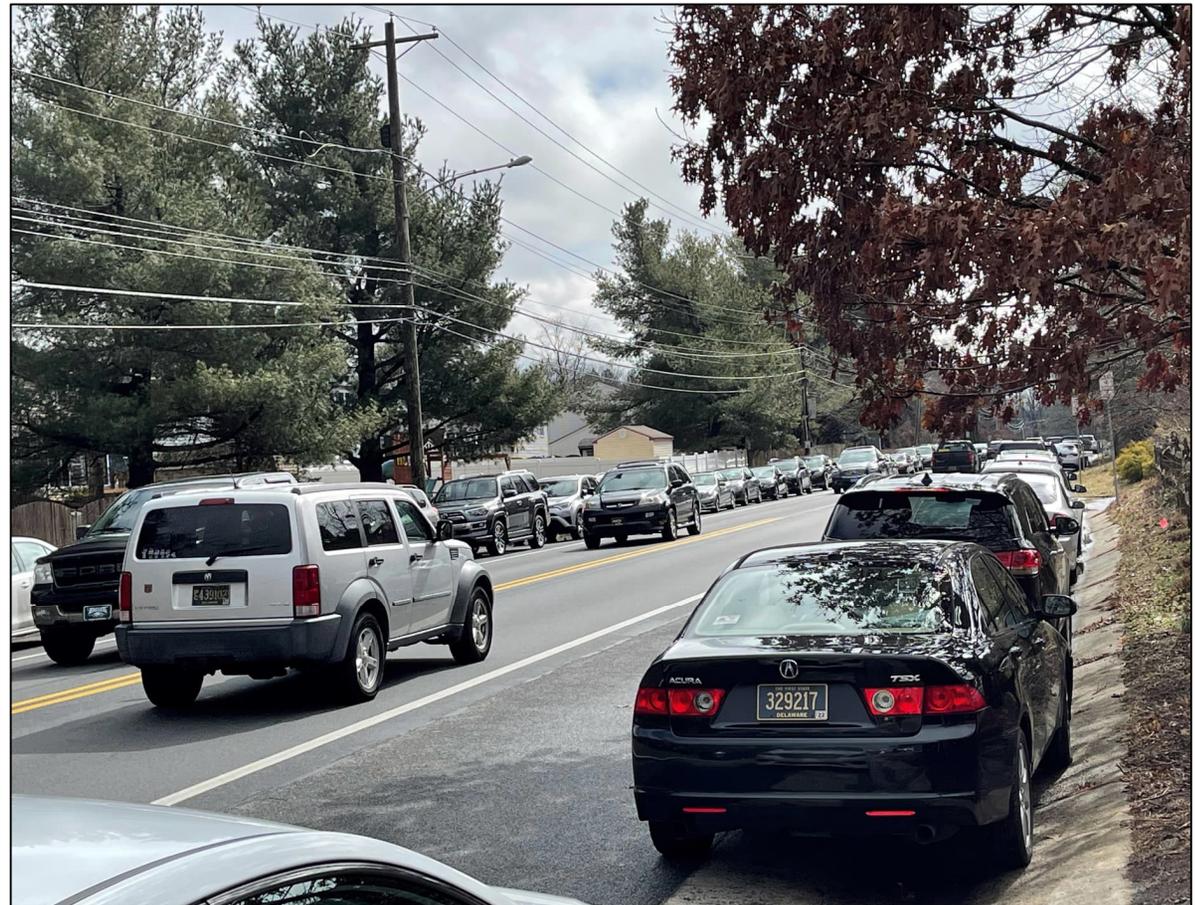
- Record Minor Land Development Plan for Islamic Society of Delaware was completed on January 20, 2000
 - Included a 10,050 SF building add-on and parking spot additions

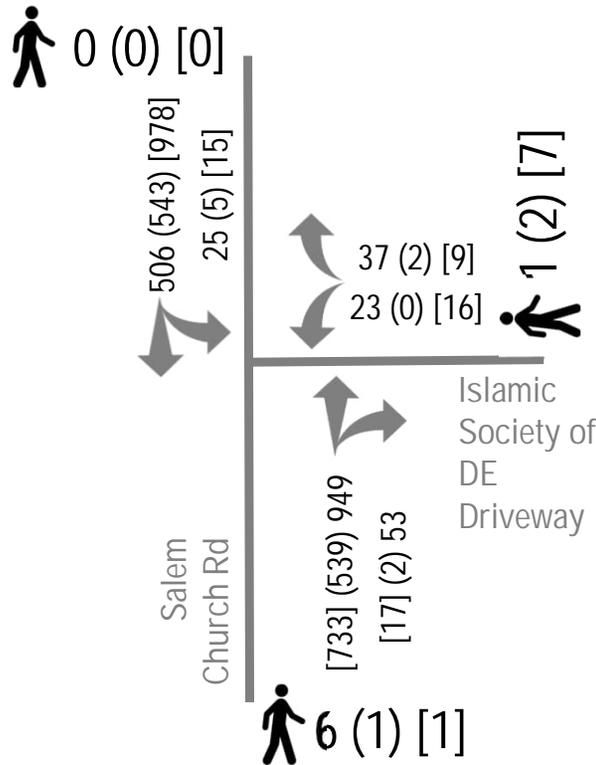
Thursday, September 15, 2022
AM (MID) [PM]

AM Peak: 7:30-8:30
MID Peak: 12:00-1:00
PM Peak: 4:00-5:00

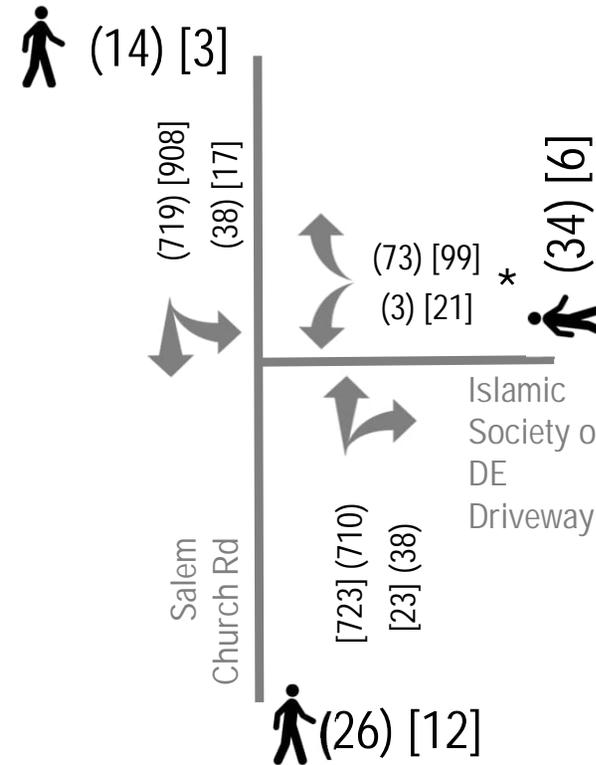
Friday, September 16, 2022
(ENTER) [EXIT]

Peak Event Entering: 1:45-2:45 PM
Peak Event Exiting: 2:45-3:45 PM

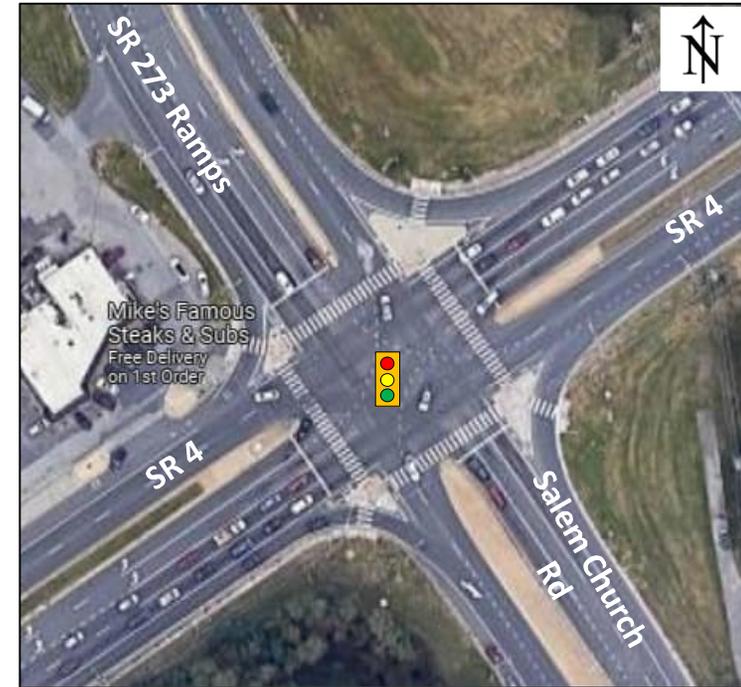
SR 4 at Salem Church Road

- ISD personnel indicated that a second NB left-turn lane would mitigate traffic delays during ISD dismissal periods
 - Taken from raised concrete median area
 - Analysis indicated improved delays and queuing for NBL and overall intersection

- Install additional northbound left-turn lane using existing concrete median area
- **STATUS: DESIGN COMPLETE**
- **GOAL: READY FOR SIGNAL CONSTRUCTION IN FY2024**

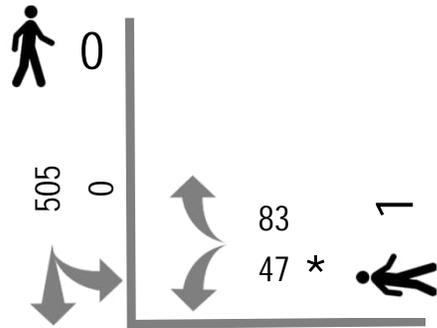
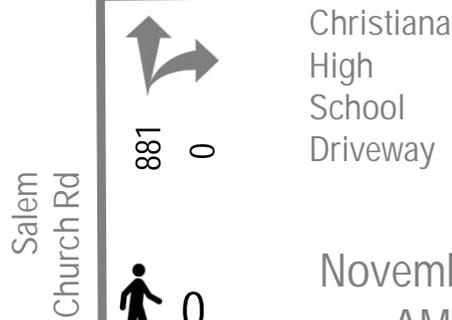
Arrival

Thursday,
November 3rd, 2022
AM (7:00 – 8:00)

Wednesday,
January 25th, 2023
AM (7:00 – 8:00)

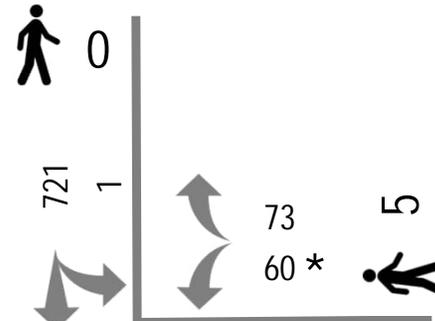
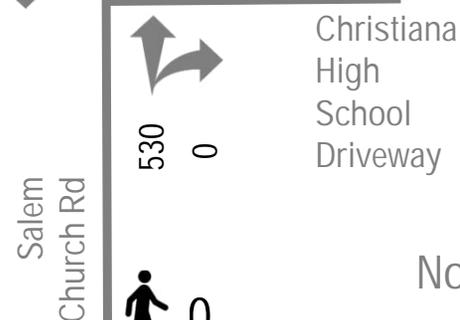
Dismissal

Thursday,
November 3rd, 2022
PM (2:00 – 3:00)

Tuesday,
January 24th, 2023
PM (2:00 – 3:00)

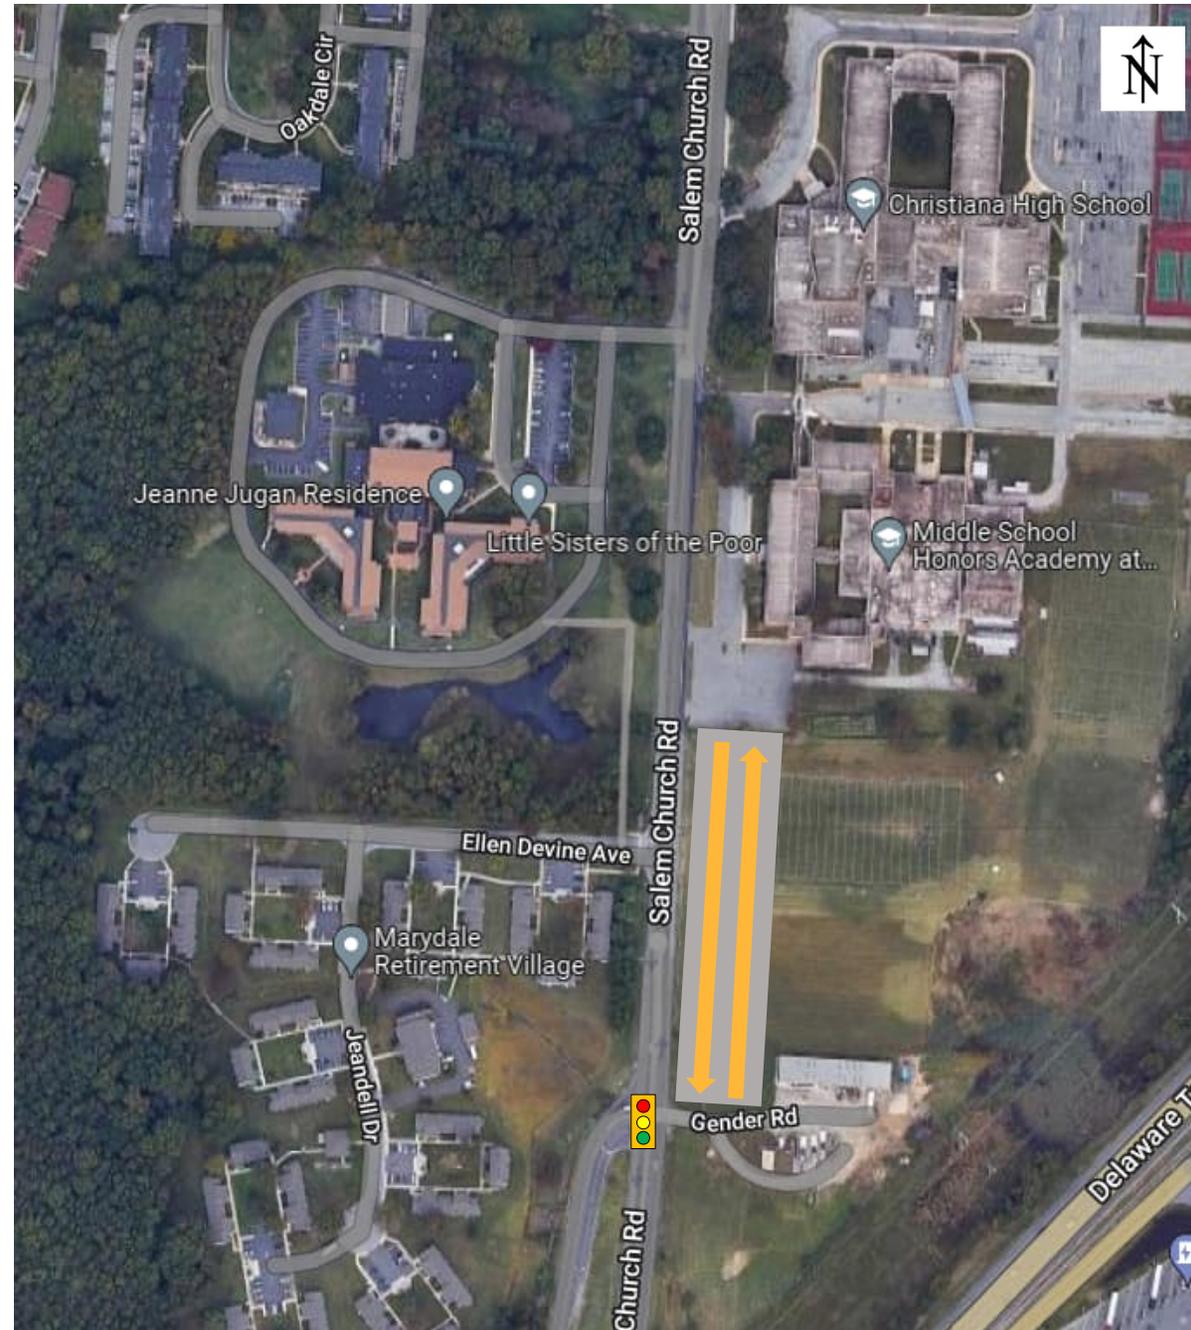
- Establishing a connector road between the school parking lot and the east leg of Gender Road would:
 - Better serve left-turns out of the school parking lot
 - Be more cost-effective than constructing a new signal
 - Reduce congestion by avoiding the addition of a new signal between Chapman Road and Gender Road
- Christina School District owns the east leg Gender Road parcel of land
- Diverting CHS (exit-only) traffic to Gender Road signal would result in LOS B for arrival and dismissal periods

- Planning-level study to explore opportunities for access point consolidation and potential Christiana High School access to signalized intersection
- Potential solutions should include adding a signalized crosswalk to Salem Church Road at Gender Road

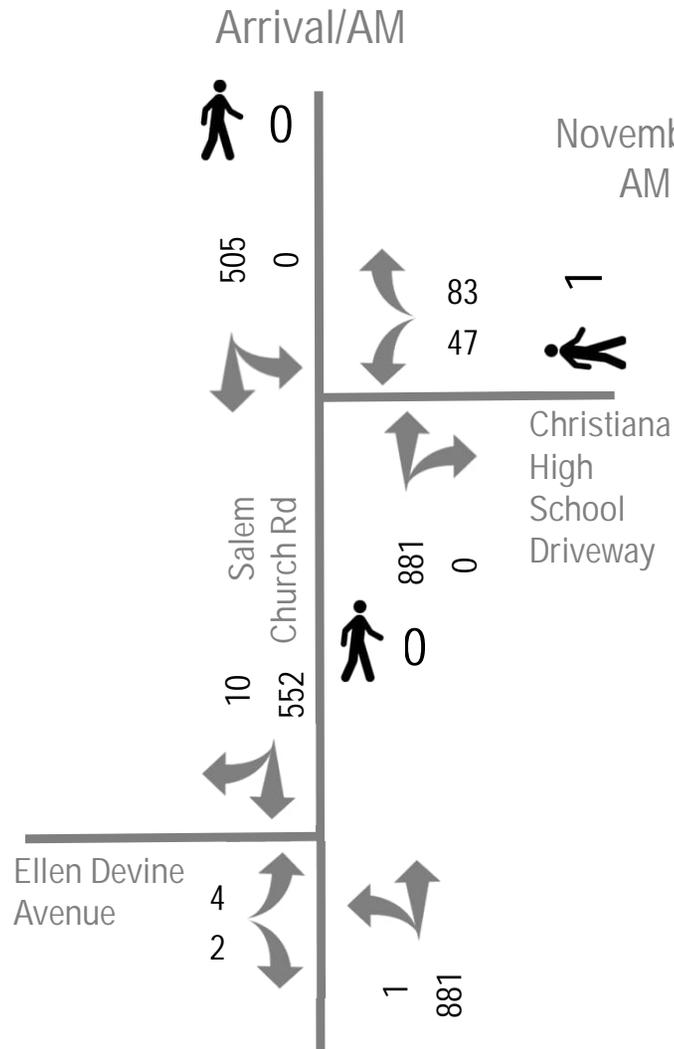
Wednesday,
January 18th, 2023
AM (7:30 – 8:30)

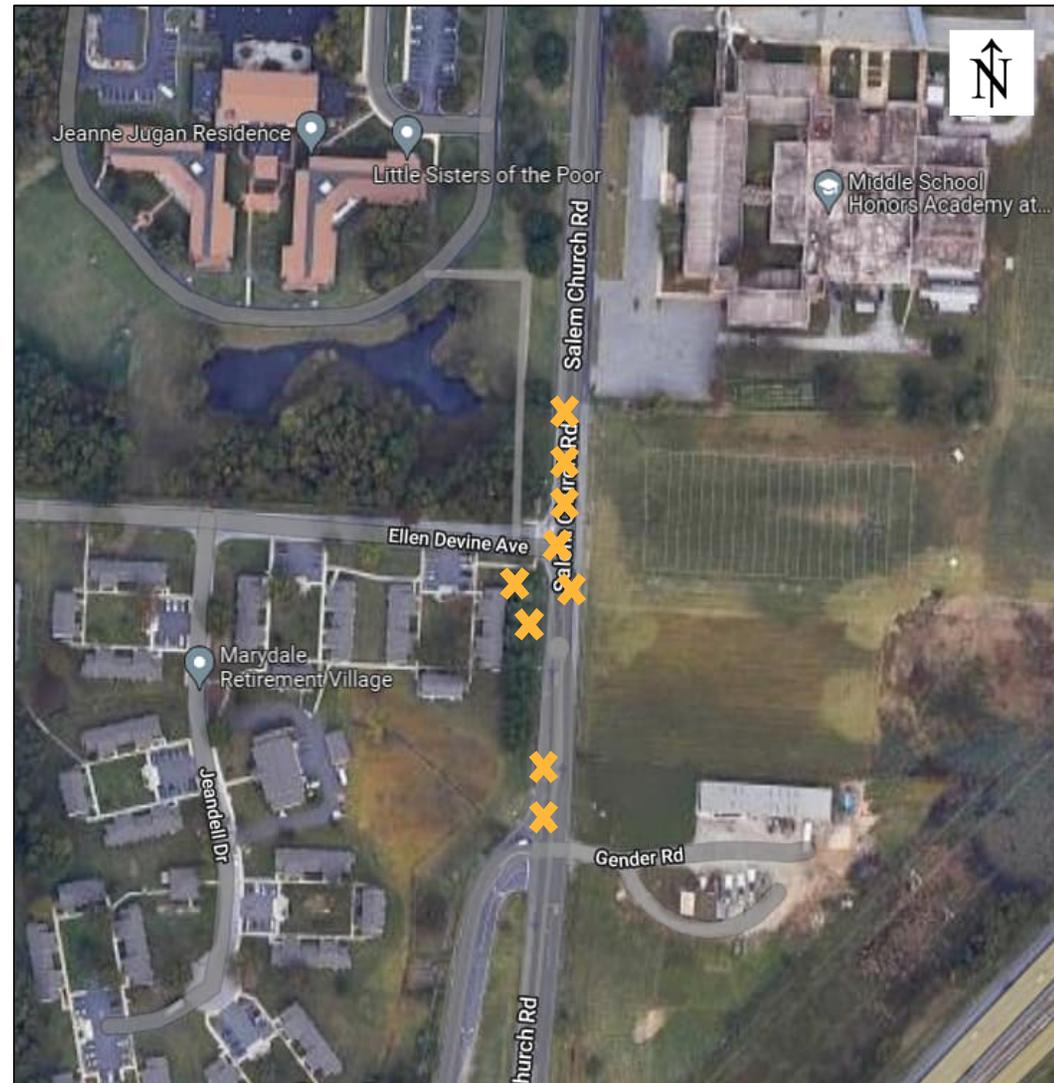
- Full-width shoulders are shown in blue
- No existing bike lanes on this portion of Salem Church Road
- Not presently programmed for resurfacing

Beginning Point	Ending Point	Distance
NB Salem Church Road	Christiana High (south) School driveway	Christiana High (north) School driveway	550 ft
SB Salem Church Road	Little Sisters of the Poor driveway	Christiana High (south) School driveway	600 ft
	Gender Road	250 ft south of Gender Road	250 ft
		Total shoulder distance:	1,400 ft

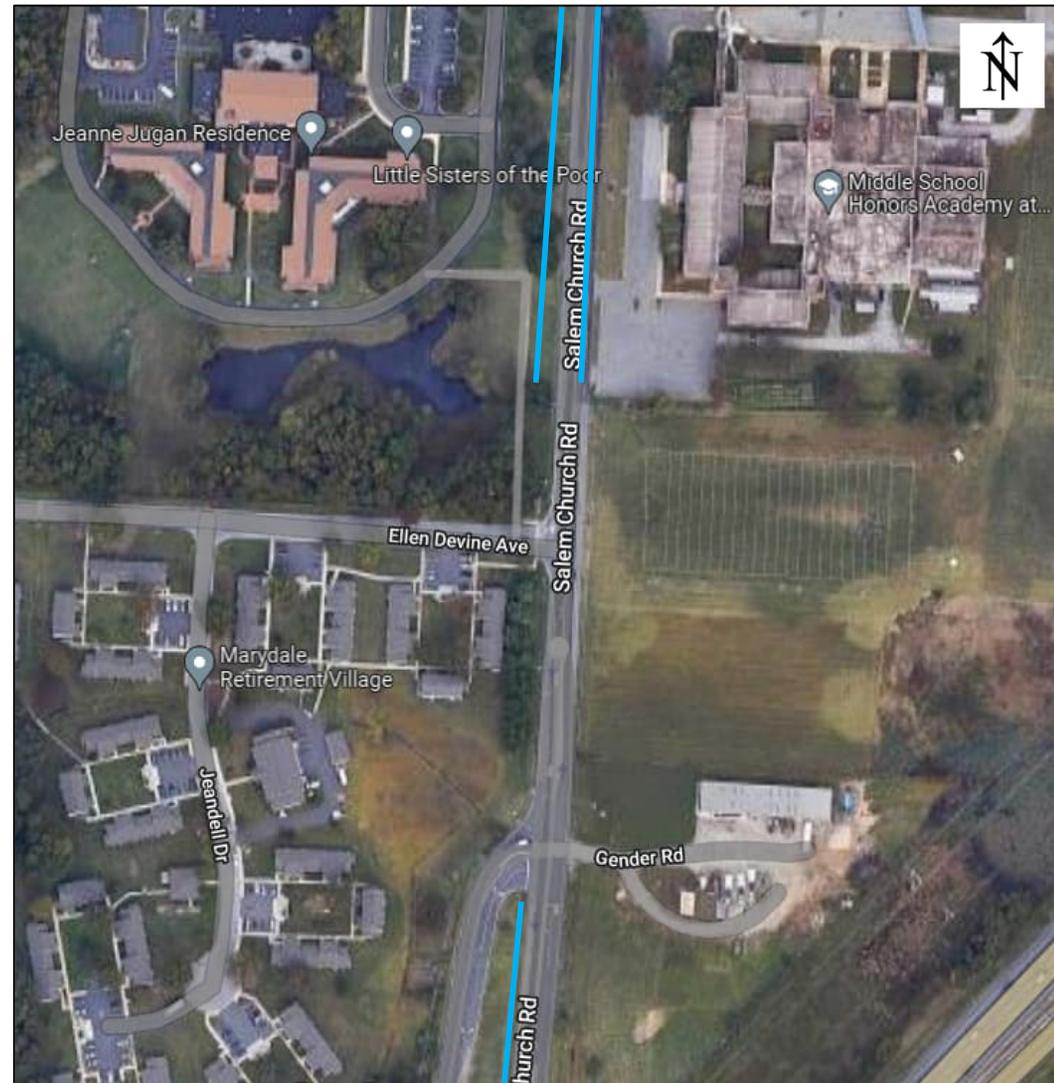
Field Observations

- Occurred on January 18, 2023, between 7:30 AM – 8:30 AM and 4:00 PM – 5:00 PM
- Sight distance is obstructed by small building on the NW corner and trees on the SW corner
 - Caused vehicles to pull up approx. 25 feet beyond the stop line (shown on the right)
- One pedestrian was observed during the AM observations
- One pedestrian and one bicyclist were observed during the PM observations
- Sidewalk continues from Ellen Devine Avenue to the Little Sisters of the Poor property and then terminates
- Signs and pavement markings in good shape

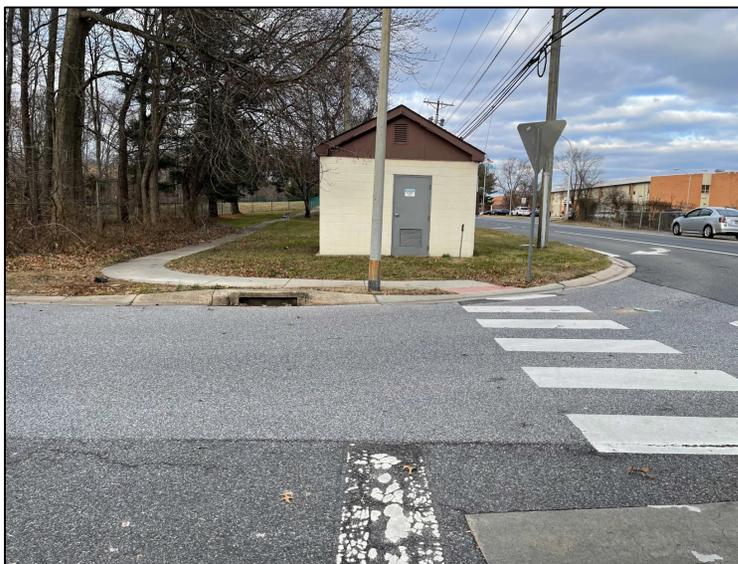
Sight Distance Looking Left

Intersection Sight Distance		
Required	Looking Left	Looking Right
	390 ft	390 ft
Measured	Looking Left	Looking Right
	130 ft	140 ft
Pulled Up	Looking Left	Looking Right
	700 ft	750 ft
